# Fracture Strength of Three-Unit Implant Supported Fixed Partial Dentures with Excessive Crown Height Fabricated from Different Materials

*Journal of Dentistry, Tehran University of Medical Sciences, Tehran, Iran (2016; Vol. 13, No. 6)*

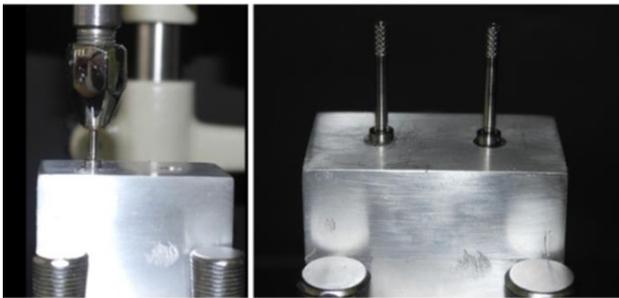
**Fig. 1:** Mounted implants parallel to each other using a surveyor

Two implants, 12mm in height and 4.5mm in diameter (Implantium; Dentium, Seoul, South Korea), were inserted in an aluminum reference model using auto-polymerizing acrylic resin (Technovits 4000; Heraeus Kulzer GmbH & Co., Wehrheim, Germany). The distance between the centers of the implants was 18mm. This distance was approximately equal to the distance between the centers of the mandibular second premolar and the second molar. A dental surveyor (J.M. Ney Co., Bloomfield, CT) was used to control the vertical and axial orientation of inserted implants (Fig. 1). Two straight abutments (Implantium; Dentium, Seoul, South Korea) with 5.5mm height and 4.5 and 5.5mm platform diameter were adapted over each implant and tightened to 35Ncm according to the manufacturer's instructions. All samples were directly fabricated on this reference model.

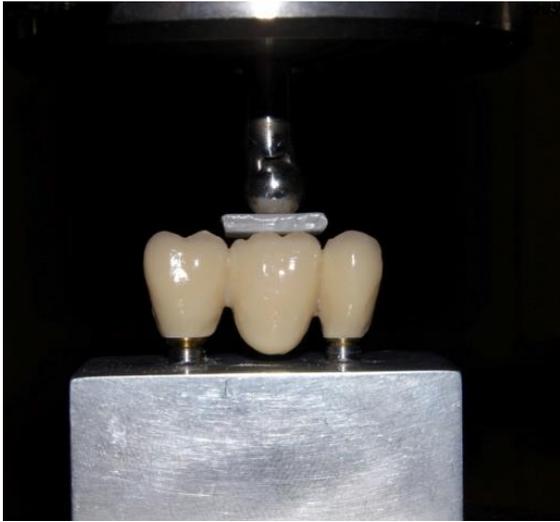
**Fig. 2:** Position of stainless steel ball and Teflon disk at loading point

Each framework was placed on the abutments and then the assembly was mounted on a universal testing machine (Z050; Zwick Roell, Ulm, Germany). Axial compressive load was applied to the center of the occlusal surface of pontic using a stainless steel ball (diameter = 8mm) at a constant crosshead speed of 0.5 mm/minute. To prevent any contact damage and to provide homogeneous load distribution on the pontic, a 2mm thick Teflon disk with length and width of 10 $\times$ 10mm, was placed between the stainless steel ball and the occlusal surface of the pontic (Fig. 2). Loading was continued until catastrophic fracture of the samples occurred. The data of failure load were recorded using computer software (Zwick's test Xpert v2; Zwick, Ulm, Germany), and registered in Newtons (N).

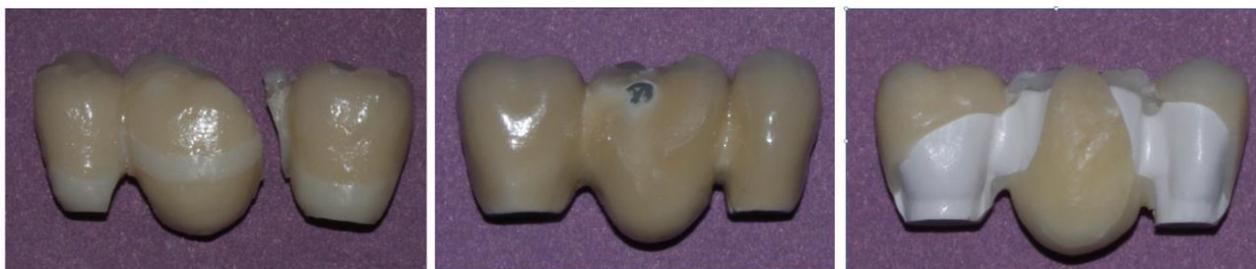
**Fig. 3:** Examples of a fractured FPD (left to right: zirconia, metal ceramic and PEEK restorations)

The fracture mode in all metal-ceramic samples was mixed (combination of adhesive and cohesive in the veneering porcelain) and Ni-Cr framework remained intact. The fractures occurred in lingual surface of pontic in three cases, and in buccal surface of pontic in seven cases. In all the zirconia samples, fractures were oblique and located between loading point and one of the connectors. Six samples fractured through the distal (molar) connector and four samples fractured through the mesial (premolar) connector. The fracture mode in all zirconia samples was cohesive, which initially occurred in the veneering porcelain and was then propagated to the framework.

In four samples, adhesive failure was also observed between the framework and porcelain. The fracture mode of all PEEK samples was adhesive, which occurred between the

framework and the veneering composite. In four samples, the failure was confined to the pontic and in six samples, the fracture extended to the molar and premolar retainers (Fig. 3).
