A 7-Year Follow-up of a Fractured Endodontically Treated Incisor Restored with a One-Piece Post and Core Laminate Veneer

Article type:
Case Report

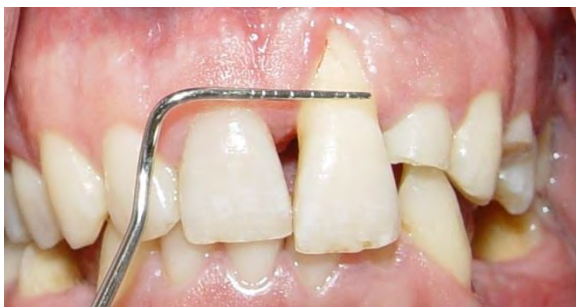
A 26-year-old man, who had a car accident resulting in bone and tooth fractures, referred for treatment. Clinical and radiological examinations revealed loss of periodontal support, extrusion of the left maxillary central incisor, and fracture of the middle third of the left maxillary lateral incisor crown (Fig. 1).

Fig. 1. Patient's intra oral condition after an accident

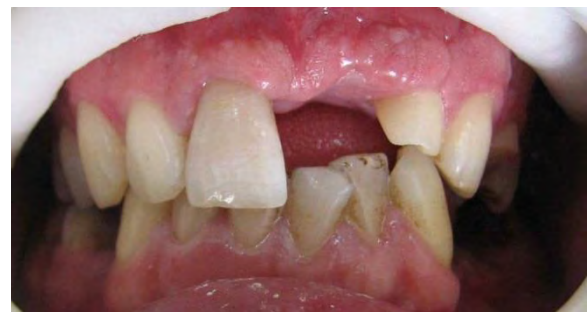
After tooth extraction, periodontal surgery was performed to provide an appropriate amount of soft and hard tissues in the aesthetic zone. Figure 2 shows the difference in soft and hard tissues after periodontal surgery. After eight weeks, an implant was placed at the site of the central incisor.

Fig. 2. Difference in soft and hard tissue after the periodontal Surgery

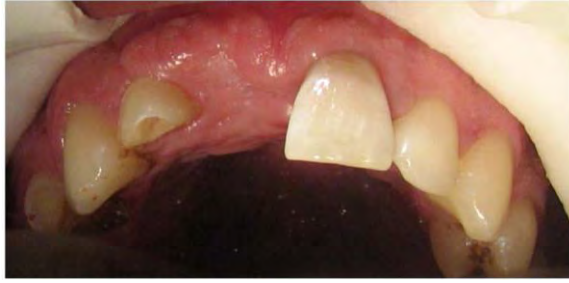
The preparation of the distal aspect of the tooth was elbow-shaped; therefore, the distal contact would not open. The mesial preparation extended to the palatal surface but the contact of the opposing tooth was kept on enamel and did not involve the finishing line or the porcelain structure. Finally, all the sharp angles were slightly rounded (Fig. 3).

Fig. 3. Preparation of right lateral incisor for one-piece feldspathic coronal post and laminate veneer restoration

After shade selection using the VITA Toothguide 3D-MASTER, the tooth structure was prepared for a resin-bonded one-piece post and core porcelain laminate veneer restoration. A 0.2- to 0.5-mm-thick layer of the enamel on the labial surface was removed using a round end diamond bur (Tizkavan, Tehran, Iran) mounted on a high-speed, water-cooled handpiece.

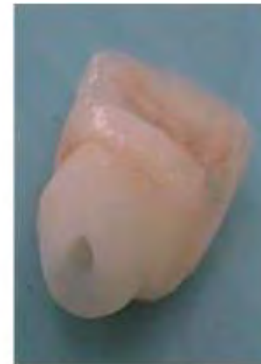
Fig. 4. Reshaped natural tooth

After extraction, the central incisor was placed in normal saline until the healing of the site of periodontal surgery. An implant (XiVE®, DENTSPLY Friadent, Mannheim, Germany) was placed at the site of the central incisor in two stages. Then, the root of the natural tooth was cut, and its crown was reshaped to be used as a provisional long-term restoration as well as a gingival former to shape the papilla in the aesthetic zone (Fig. 6). The natural tooth crown was bonded to the adjacent central incisor using resin composite (Premise, Kerr Corp., Orange, CA, USA).

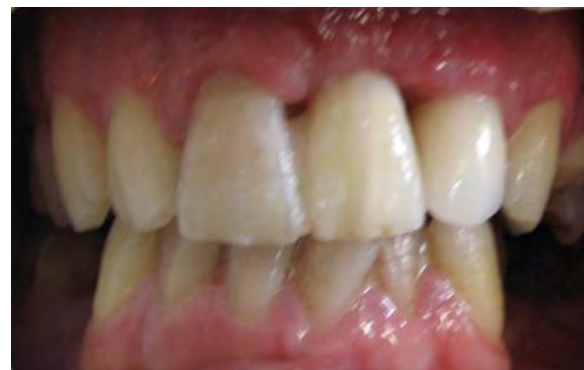
Fig. 5. Bonded central incisor natural tooth crown and one-piece post and core laminate veneer for lateral (Labial view)

were then rinsed thoroughly and lightly dried. Then, 1-2 coats of All Bond 2 (Bisco Inc., Schaumburg, IL, USA) were applied to dentin and enamel, air-dried for 10 seconds, and then cured with light-emitting diode (LED) curing light (Guilin Woodpecker Medical Instrument Co., Ltd., Guangxi, China) at the light intensity of 900 mW/cm² for 10 seconds. A dual-cure cement (Duolink; Bisco Inc., Schaumburg, IL, USA) was placed on top of the coronal post, and a translucent light-cure cement (Choice 2 veneer cement; Bisco Inc., Schaumburg, IL, USA) was applied to the inner surfaces of the restoration. The restoration was then inserted and cured for 5 seconds, and then, the excess cement was removed. Polymerization of the luting agent was completed by light-curing each surface of the restoration for 60 seconds. Finally, the occlusion was checked (Fig. 4 and 5).

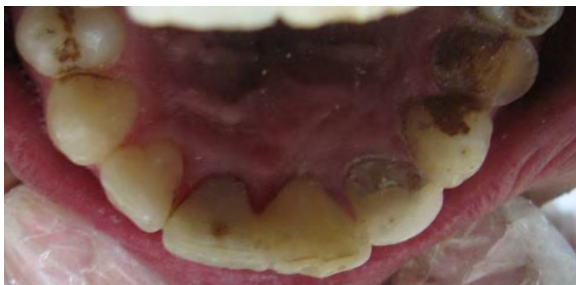
Fig. 6. Palatal view of the bonded central incisor natural tooth crown and the one-piece post and core laminate veneer for the lateral incisor

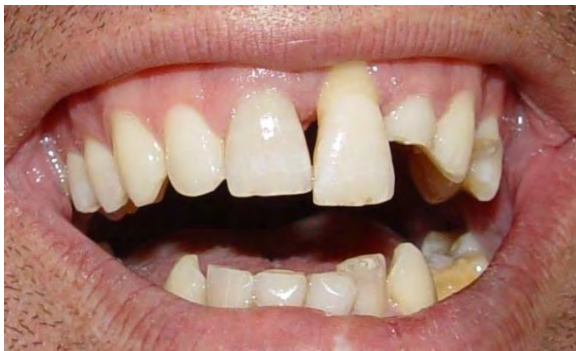
Fig. 7. Patient's smile before treatment

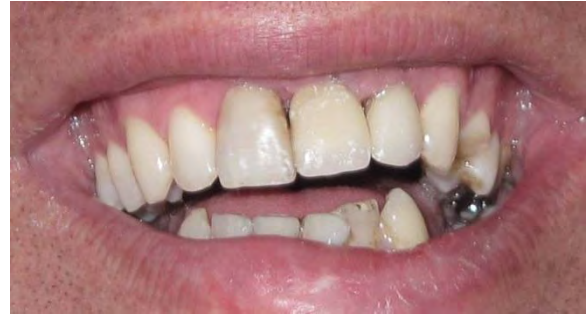
Fig. 8. Patient's smile after treatment

Six months after implant placement, the natural tooth crown was removed, and the prosthetic crown of the implant was delivered (Fig. 7 and 8).

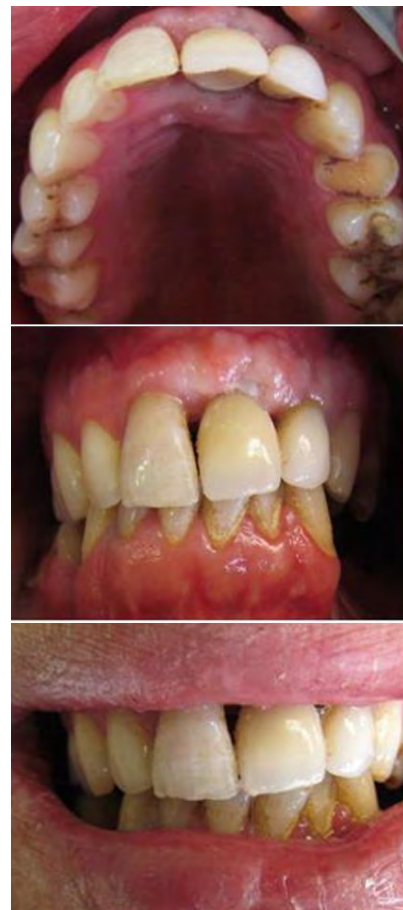
After seven years of follow-up, there was no marginal discoloration in the laminate veneer crown, and color stability was satisfactory. There were no debondings or abrasions in the mandibular teeth and no recession in the soft tissue around the implant. The level of the periodontium was preserved in a good position (Fig. 9).

Fig. 9. Patient after 7 years follow-up
