Covering the Screw-Access Holes of Implant Restorations in the Esthetic Zone: A Clinical Report

Journal of Dentistry, Tehran University of Medical Sciences, Tehran, Iran (2014; Vol. 11, No. 6)

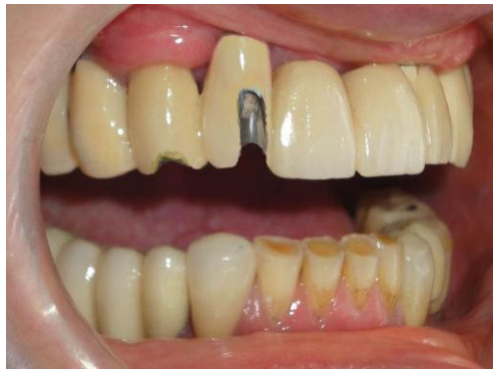
Fig 1. Porcelain chipping around the screw access holes.

A 51 year-old woman was referred to the Prosthodontics Department of Shahid Beheshti University, School of Dentistry to assess teeth 12 and 13 (FDI two digit tooth numbering system) screw-retained fixed implant restorations (Figure 1).

Clinical examination revealed that the anterior segment of the maxilla had a six-unit screw-retained FPD (Figure 1). Four implants in the maxillary right and left lateral and canine areas supported this FPD (Figure 2).

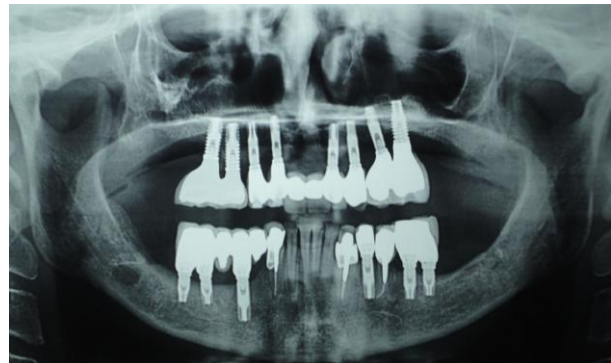
Fig 2. Panoramic view of the patient's mouth.

Four years ago, she received dental implants to restore edentulous spaces in both jaws with implant-supported fixed prosthesis (Figure 2); 6 months after delivery of

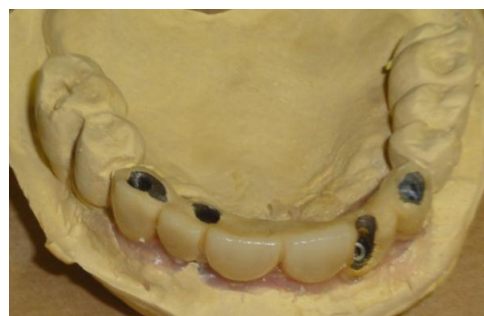
Fig 3. Buccally located screw access holes.

The extreme buccal angulation of the implant replacing teeth 12 and 13 resulted in a buccally-located screw access hole, which compromised esthetics and potentially weakened the porcelain around the screw holes in the six-unit screw-retained FPD. In lateral excursions canine guidance distributed forces to the canines.

separation of FPD from the cast and then the impression was poured with type 4 dental stone (Vel-Mix, Ernst Hinrichs GmbH, Germany). Buccally located screw access holes are shown in Figure 3.

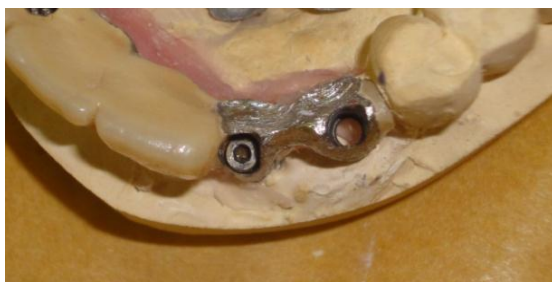
Fig 4-1. Prepared metal substructure: occlusal view.

All the porcelain on the labial and palatal one-third of the lateral and canine teeth was removed with green stone and then metal was removed in the same places to gain space for metal and porcelain of the over casting crowns (Figures 4-1 and 4-2).

Finally deep chamfer finish line was designed in the palatal surface with chamfer diamond bur. In the labial surface because of the limitation in metal volume, light chamfer finish line was designed. Die spacer (EURO CLASSIC DIE SPACER, Kerr, Orange, CA) was applied to the prepared frame but not in the screw access holes. For adequate marginal adaptation, a band of about 1 mm, not painted, adjacent to the preparation margin immediately.

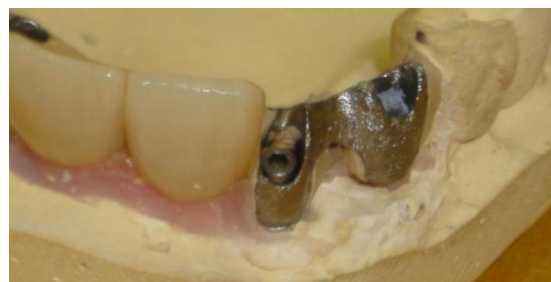
Fig 4-2. Prepared metal substructure: labial view.

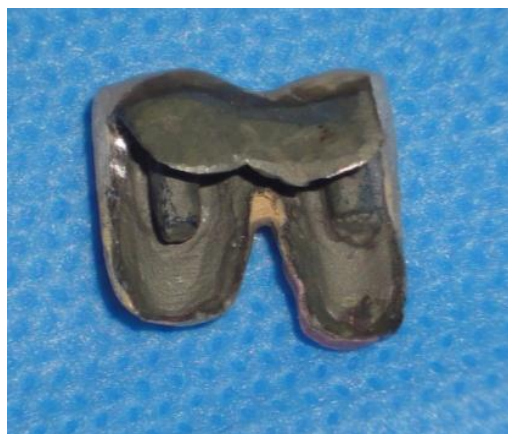
Fig 5-1. Splinted over casting crowns: palatal view.

Vaseline was applied to the prepared frame to lubricate it and then full contour resin pattern (GC resin pattern, Tokyo, Japan) was fabricated on it. This pattern penetrated the screw access holes until 1mm from the head of screws remained. Once the final contour of the resin pattern was completed, the pattern was cut back over a uniform thickness of about 1 mm to provide room for the porcelain fused to the cast metal substructure. Finally, thickness of metal framework was 0.2 mm in the cervical area to 0.5 mm in the incisal area. Investing and casting procedures were done and porcelain was applied to the metal framework (Figures 5-1 and 5-2).

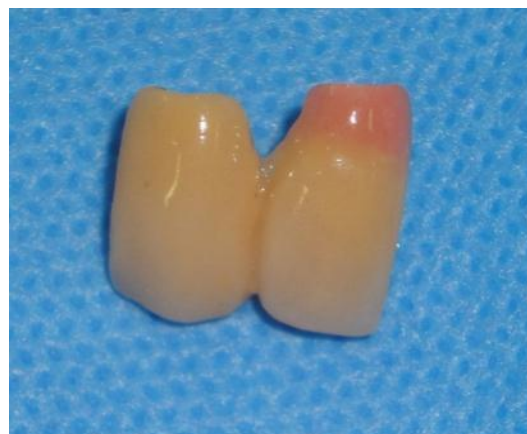
Fig 5-2. Splinted over casting crowns: labial view.

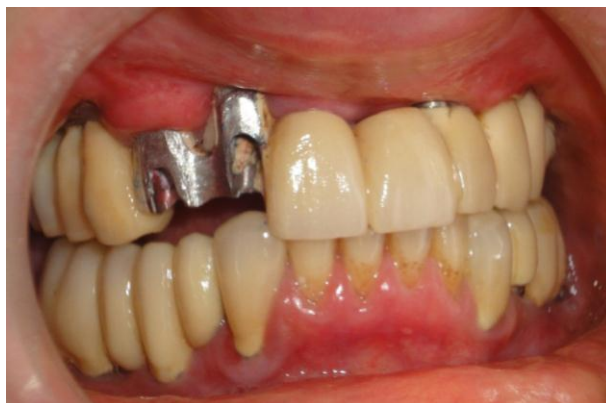
Fig 6. Intraoral view of six-unit screw-retained FPD without splinted over casting crowns.

Six-unit screw-retained FPD was placed into the patient's mouth and was secured by tightening the screws (Figure 6). Splinted over-casting crown was tried in the mouth and color coordination was done by applying stain (Figure 7).

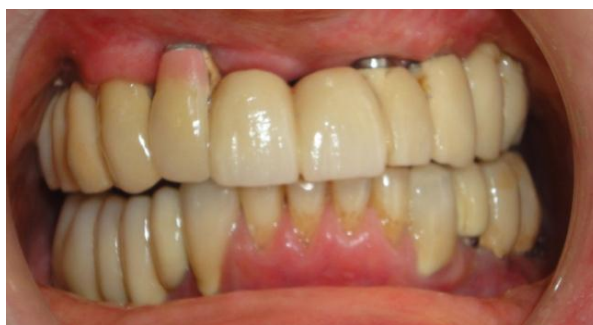
Fig 7. Intraoral view of screw-retained six-unit FPD with splinted over casting crowns in place.

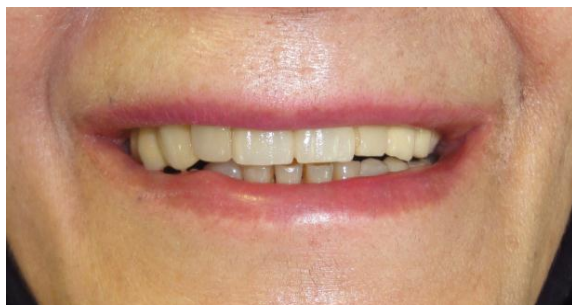
Fig 8. Delivered Prosthesis.

Then, a small amount of gutta-percha was placed over the head of screws. The splinted over casting crown was glazed and cemented with temporary cement (Temp Bond NE, Kerr, Orange, CA, USA) (Figure 8).
